# Homebuyer Drain Survey

Sample property - customer and address details removed

Project Name: Sample Homebuyer Survey

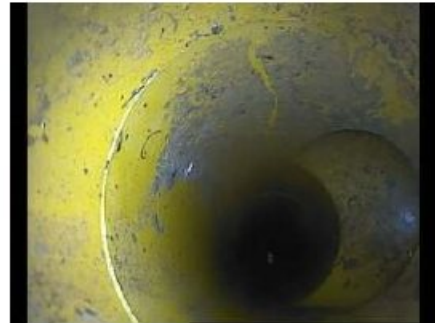
2) gully blind

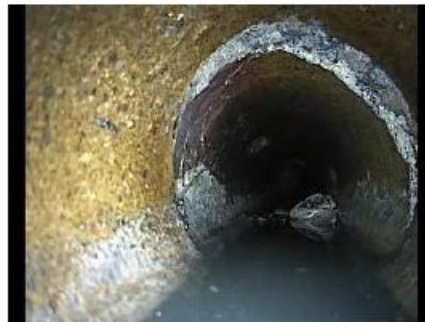
section5\_2.png

2) Medium Displaced Joint (from 12 o'clock to 4 o'clock)

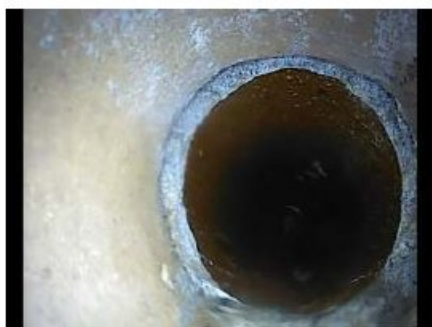
section5\_3.png

3) Medium Displaced Joint (from 12 o'clock to 4 o'clock)

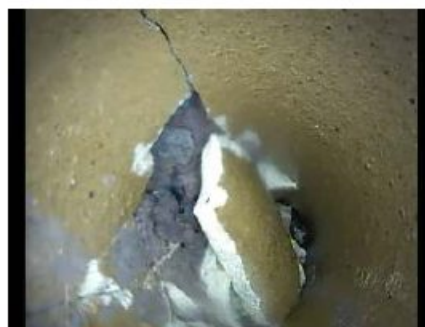
section5\_4.png

4) Hole in Pipework (from 12 o'clock to 4 o'clock)

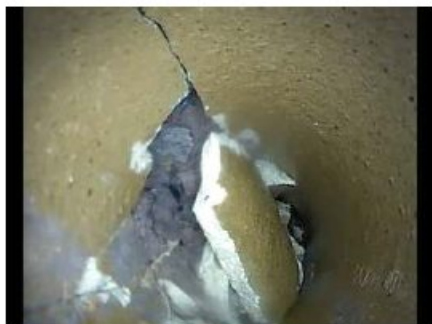
section5\_5.png

5) collapsed pipe

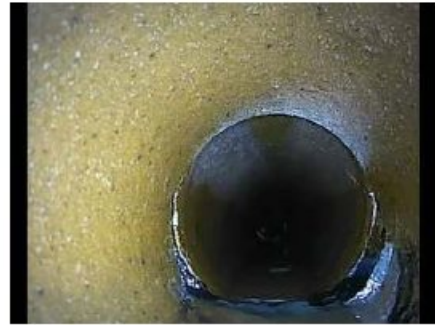
section6\_2.png

2) Crack at joint (from 12 o'clock to 4 o'clock)

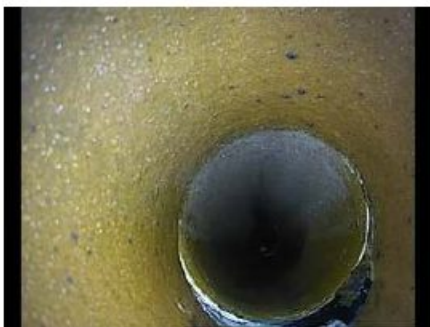
section6\_3.png

3) Crack at joint (from 12 o'clock to 4 o'clock)

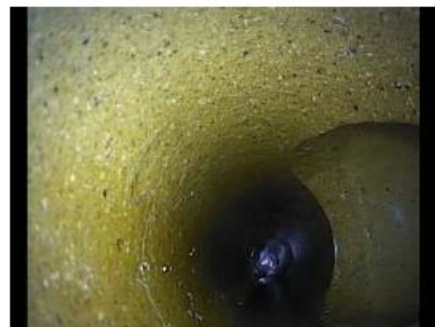
section6\_4.png

4) blind drop

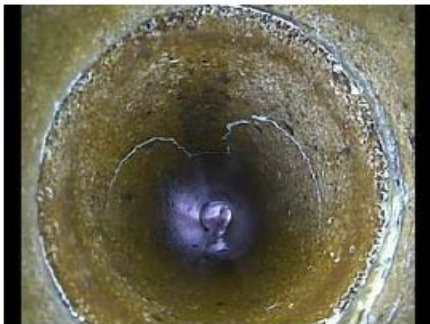
section6\_5.png

5) Crack (from 12 o'clock to 4 o'clock)

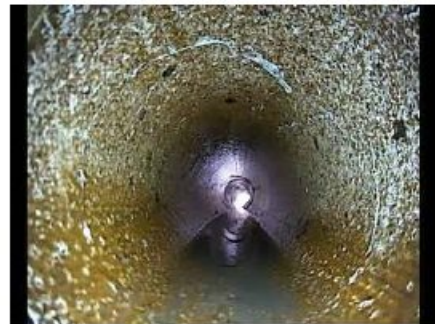
section6\_6.png

6) Crack (from 12 o'clock to 4 o'clock)

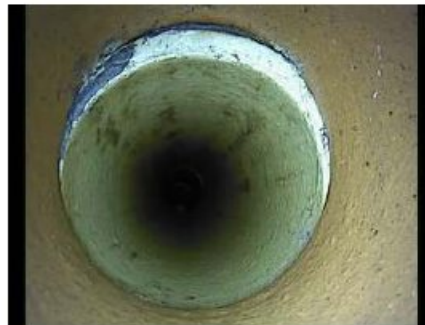
section7\_2.png

2) Medium Displaced Joint (from 12 o'clock to 4 o'clock)

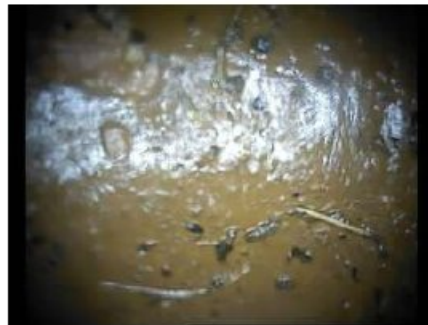
section8\_2.png

2) End Point septic\_tank\_

The property is served by an older two-chamber brick-built septic tank. The existing concrete access covers are heavily aged and fitted with makeshift metal lifting handles and are considered unsuitable for continued use.

Investigation established that the septic tank outlet connects into a solid surface-water type pipe, which runs downhill and ultimately discharges onto an open slope, with no conventional drainage field identified.

Based on the findings, the existing septic tank/discharge arrangement is not considered suitable for the proposed continued use of the property. We recommend the existing system is upgraded/replaced with a compliant foul drainage solution suitable for the anticipated occupancy.

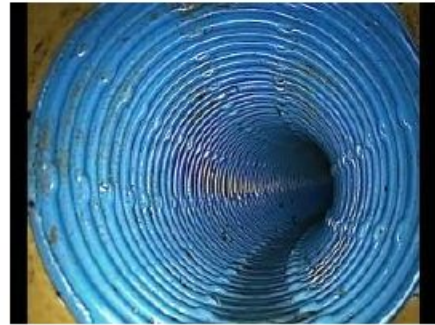
section11\_2.png

2) pipe corrugated
